CFP-SP AWHB ALL WEATHER HIGH BUILD

# Troubleshooting guide

2025 Edition

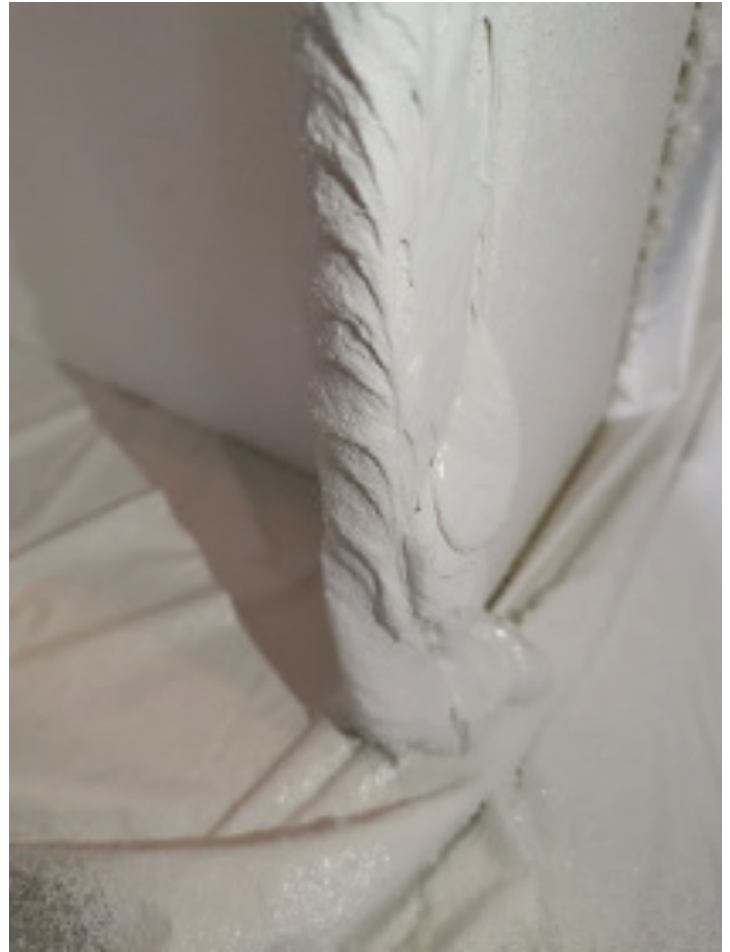
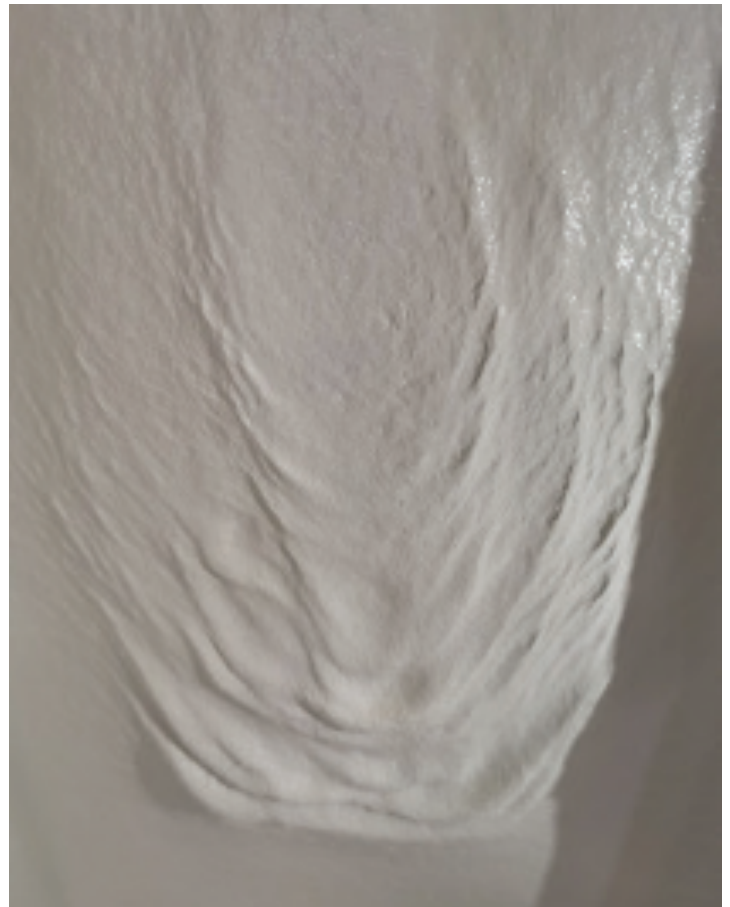
## Sagging

- Product appears to 'sag' down
- Often, beads of paint pool and run down the surface

- Applied Wet Film Thickness (WFT) significantly higher than recommended
- The product was thinned more than recommended
- Applicator stood too close to the structure during application

The maximum WFT per coat of AWHB is 350 mils.

- No action required from a fire-safety perspective — no detrimental effect on fire performance as long as required Dry Film Thickness (DFT) is met
- If superior aesthetics are required: sand to smooth surface (caution with DFT)

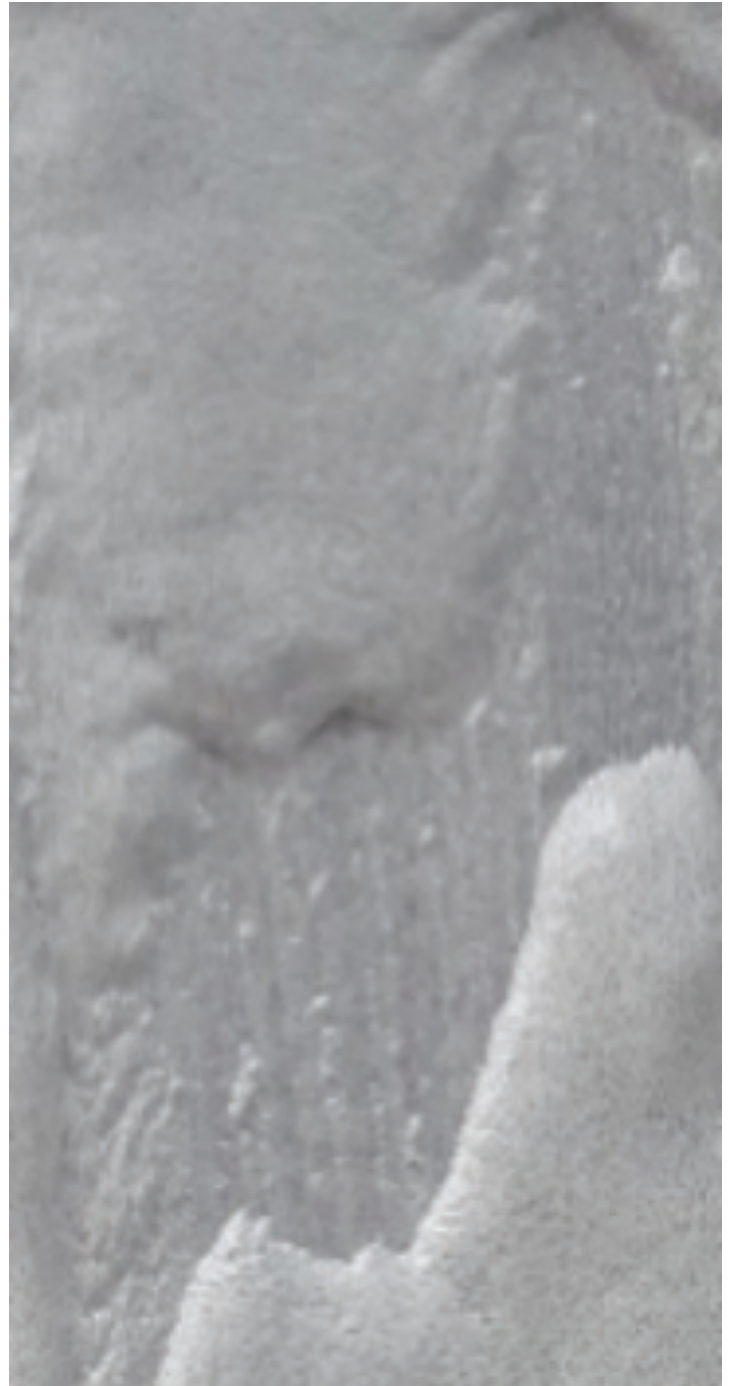
## Slumping / sliding

- The intumescent fireproofing does not adhere to the substrate and slides down as a whole layer.

- Product applied on top of incompatible substrate/primer
- Surface contamination or presence of water on substrate, leading to improper adhesion

- Complete removal of the coating

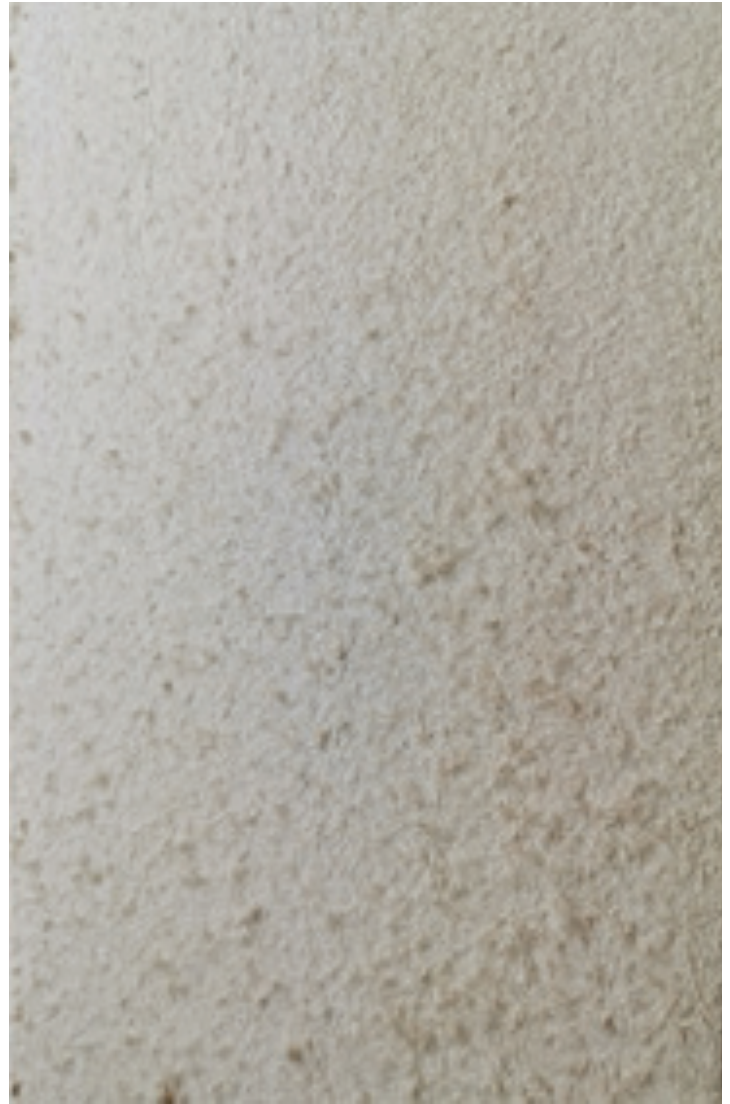
## Dry spray

- Poor atomization of intumescent material

- Applicator stood too far from structure during application
- Application temperature too high and/or humidity too high
- Pump pressure too high

- Nothing required from a fire-safety perspective — no detrimental effect on fire performance as long as required DFT is achieved
- Ensure pump pressures are within recommendations by manufacturer/in Hilti application guide
- Ensure you are at a correct spraying distance from the surface, and within product spray parameters
- If superior aesthetics are required: sand to smooth surface maintaining proper DFT

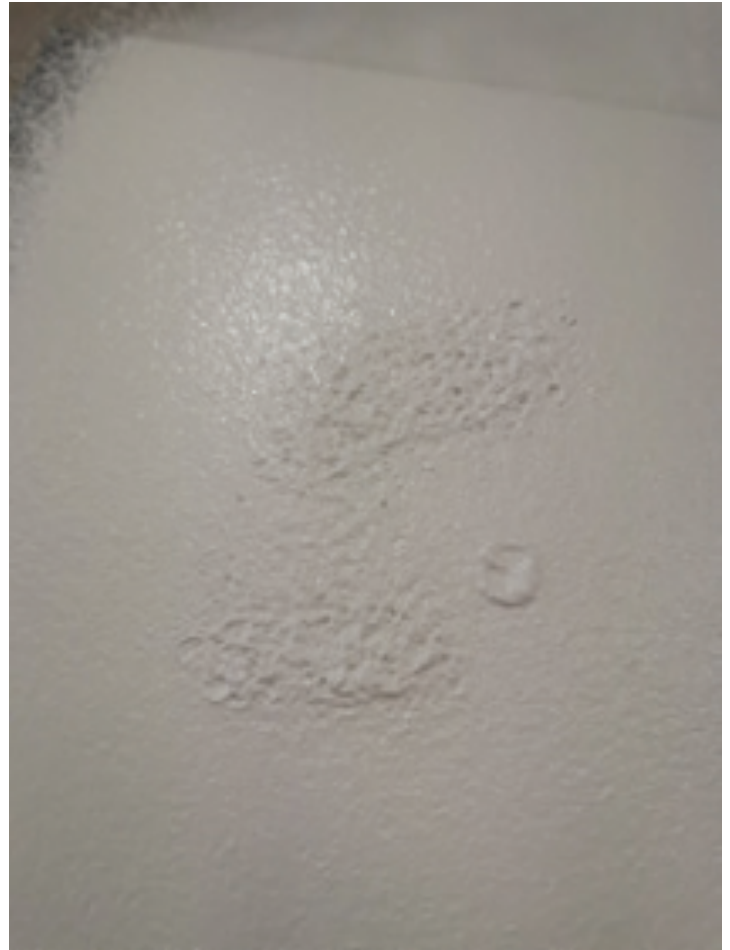
## Surges

- Intumescent material that sprays out from pump in a stream vs. an atomized spray fan

- Cavitation of the pump
- Short tip blockage
- Cured material inside the pump

- Cavitation: ensure sufficient level of intumescent in the pump feed
- Ensure that all connections of the pump are tight, and there is no air entering the pump
- Ensure that there is no dry or cured material inside the pump that can create an uneven flow
- No repairs required from a fire-safety perspective — no detrimental effect on fire performance
- If superior aesthetics are required: sand to smooth surface maintaining proper DFT

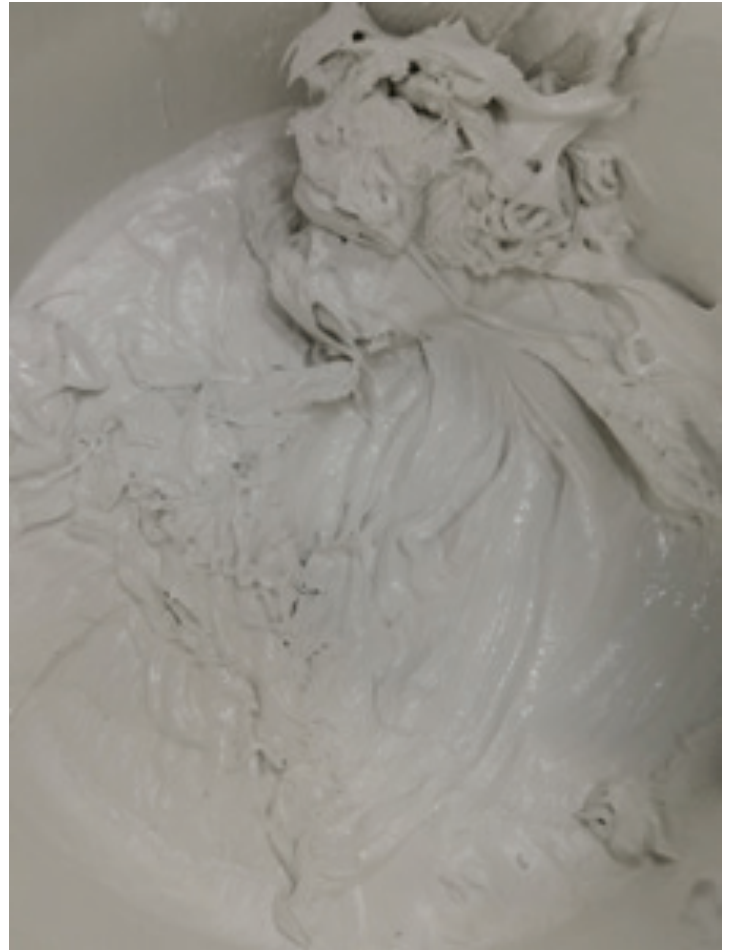
## Skin formation

- A skin layer of cured product can appear at the top of the bucket

- Due to the unique chemistry of the product that cures with the moisture of the air, a skin layer of cured material can appear at the top of the bucket
- At high temperature and humidity, the skin layer will appear sooner

- In order to avoid issues while spraying, it is very important to remove the skin layer with a spatula

To prevent the formation of skin layer you can use one of the following methods:

- Cover the intumescent material in the bucket / hopper with a very thin layer of Xylene. Please note that this may result in slight dilution, especially if incorporated into the material, with the resultant impact on the material and spraying.
- Cover the material directly with a thin plastic sheet or film. Please ensure that the plastic sheet is clean and dry to ensure that it does not interact with the intumescent coating.

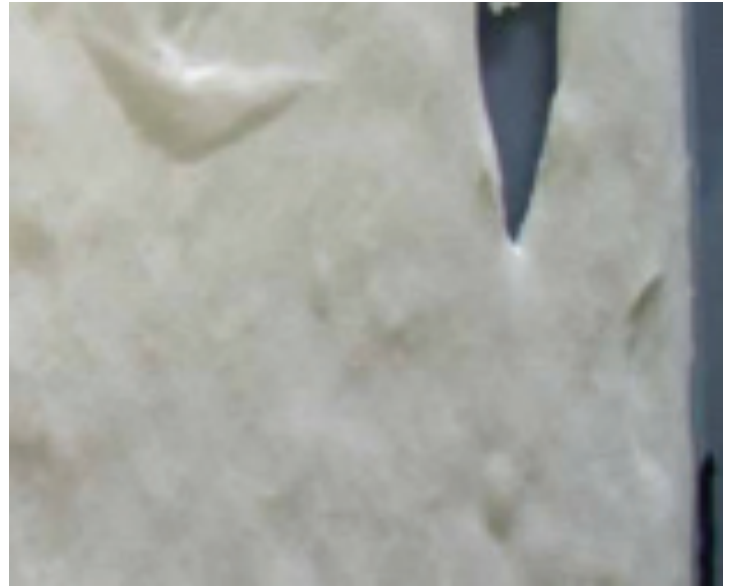
## Incompatible primer — adhesion problems

- The Hilti AWHB does not adhere to the substrate — slides off during the initial spraying / curing process or flakes when dry.

- The primer may not be compatible
- The product was applied outside of the specified recoat window of the primer
- Contamination or wet of substrate

- The Hilti AWHB product MUST be removed completely from the steel member
- Check primer compatibility (ask Hilti Technical service for approved primers list)
- Remove incompatible primer
- Remove contamination of the steel
- Apply approved primer
- Re-apply Hilti AWHB as per UL requirements

- The Hilti AWHB product MUST be removed completely from the steel member
- Remove primer
- Re-apply primer within the specs (check PDS of primer manufacturer for details)
- Re-apply Hilti AWHB as per UL requirements

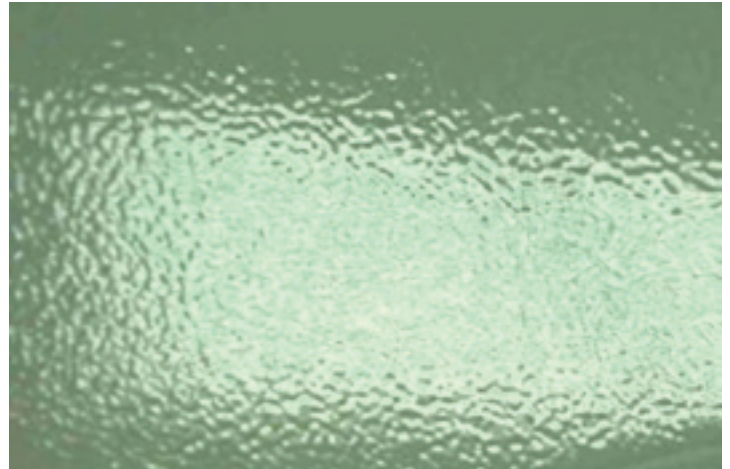
## Orange peel

- Rough textured appearance, similar to the peel of an orange, on the surface of the product

- Normal appearance for high build coatings
- High WFT have a propensity to orange peel
- High gloss topcoat exacerbates the appearance

- No repairs required from a fire-safety perspective — no detrimental effect on fire performance
- If superior aesthetics are required: sand to smooth surface maintaining proper DFT

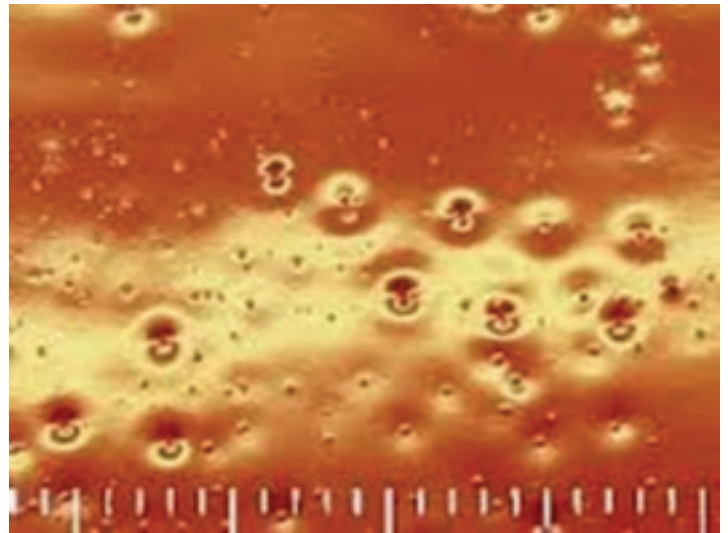
## Cratering (topcoats only)

- Pock-marked topcoat (picture on the right)

- Defect in the topcoat caused by foreign matter
- Frequently observed with polyurethane and silicone topcoats
- NOT a problem of the intumescent

- Ensure that topcoat is properly mixed. When in doubt, filter the topcoat (see recommendations of the topcoat manufacturer)
- For continued issues, contact topcoat manufacturer
- No repairs required from fire-safety perspective — no detrimental effect on fire performance
- If superior aesthetics are required: smooth topcoat and re-apply a thin layer

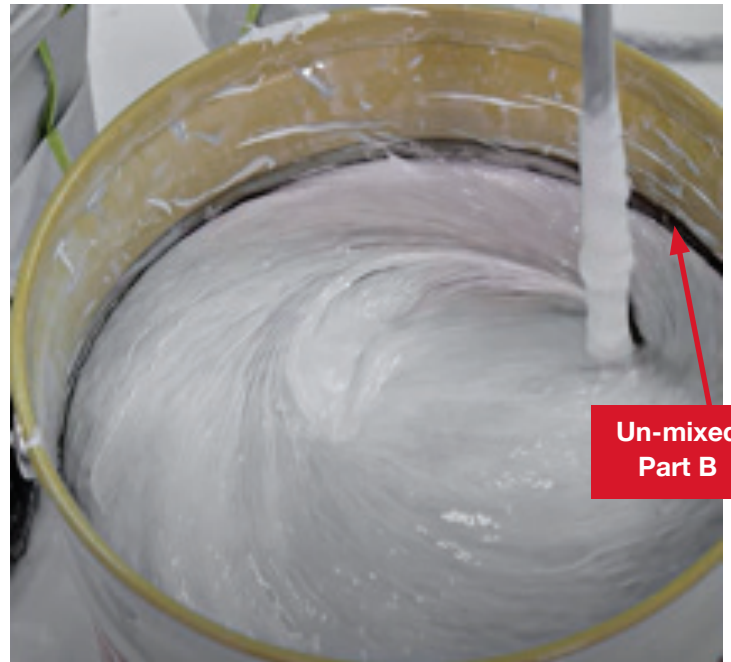
## Wrong mixing

- Uncured material (if no part B added)
- Unevenly cured areas.

- Forgetting to add Part B to Part A
- Not mixing full kit
- Component A and B have not been mixed properly

- The product must be completely removed and reapplied.
- To ensure proper mixing, the following steps must be followed:
  - Mix Part A thoroughly with a drill type mixer until homogeneous ( $\geq 1$  minute)
  - Shake part B can thoroughly before opening ( $\geq 1$  minute)
  - Pour ALL Part B into Part A bucket, and mix thoroughly with a drill type mixer until homogenous ( $\geq 1$  minute)
  - Note: Ensure that ALL the Part B product is fully mixed into Part A. Unmixed traces of Part B might stay at the sides of the tin (see picture right), please mix it all until all Part B is fully incorporated. Ensure that you only utilize full kits.
- It is possible to open and pre-mix Part A before utilizing; however, Part B should be utilized IMMEDIATELY after opening, as it is extremely moisture sensitive.
